# A Review of Criticality Accidents

William R. Stratton

revised by  
David R. Smith

March 1989

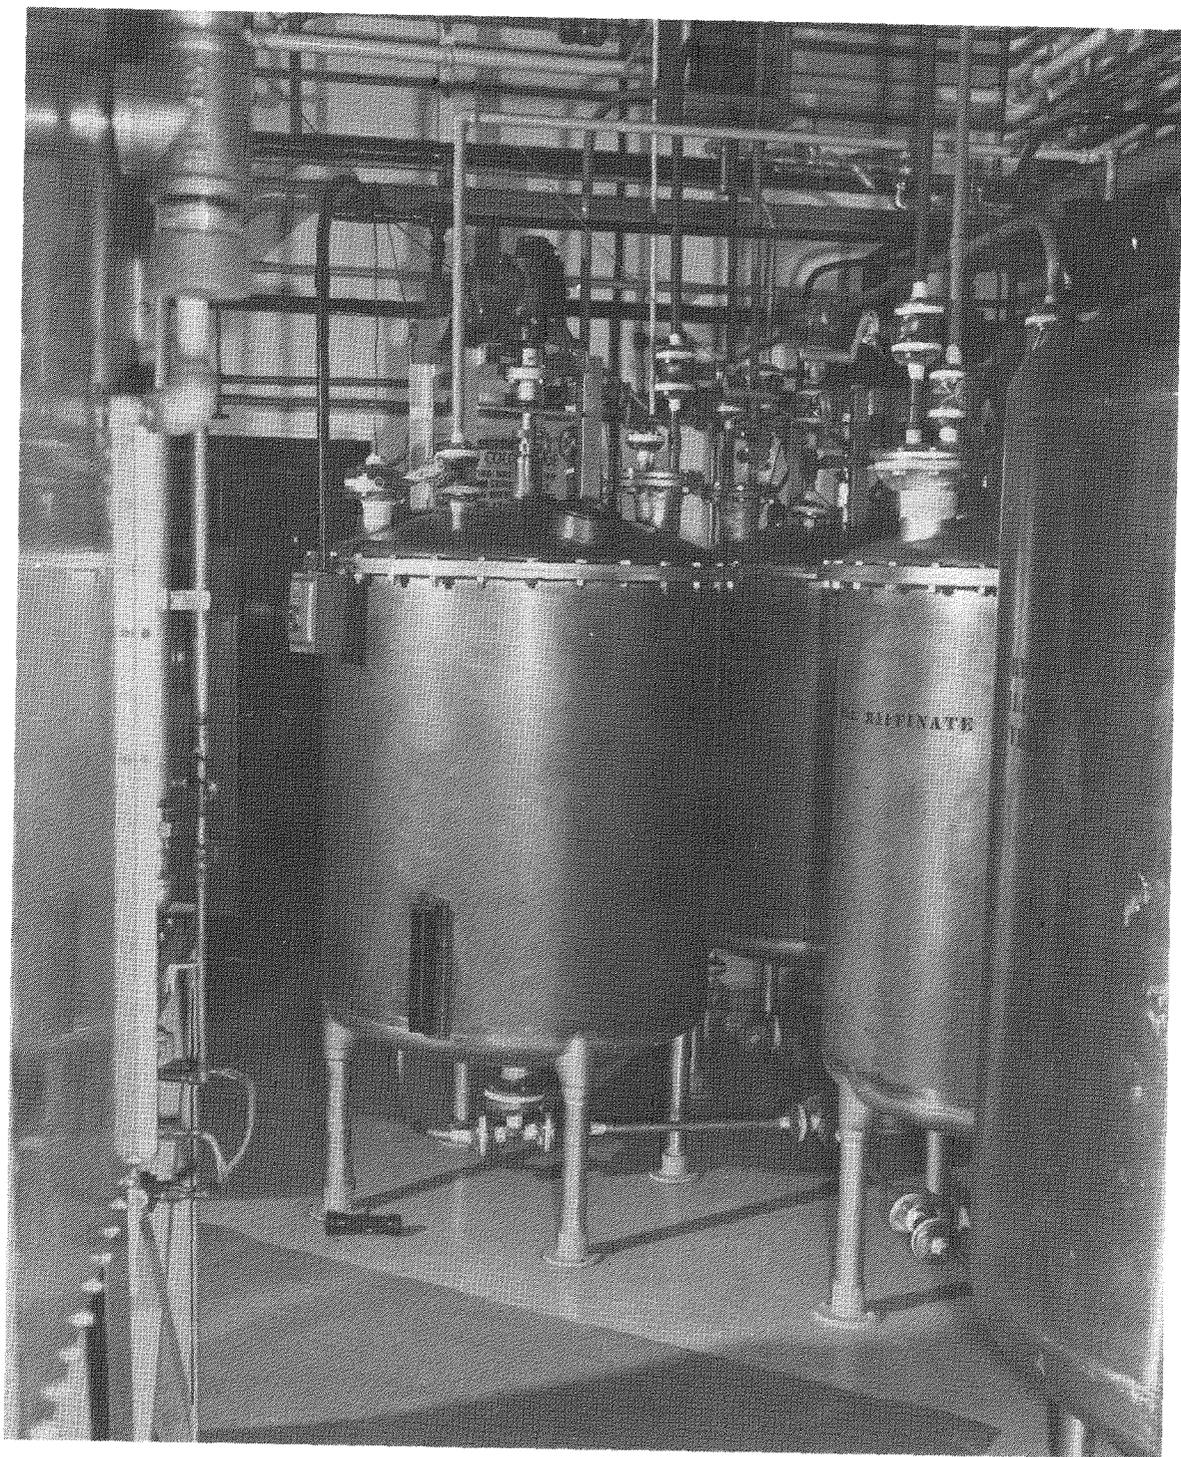
**Fig. 2. Process vessel in which the 1958 Los Alamos plutonium solution accident occurred.**

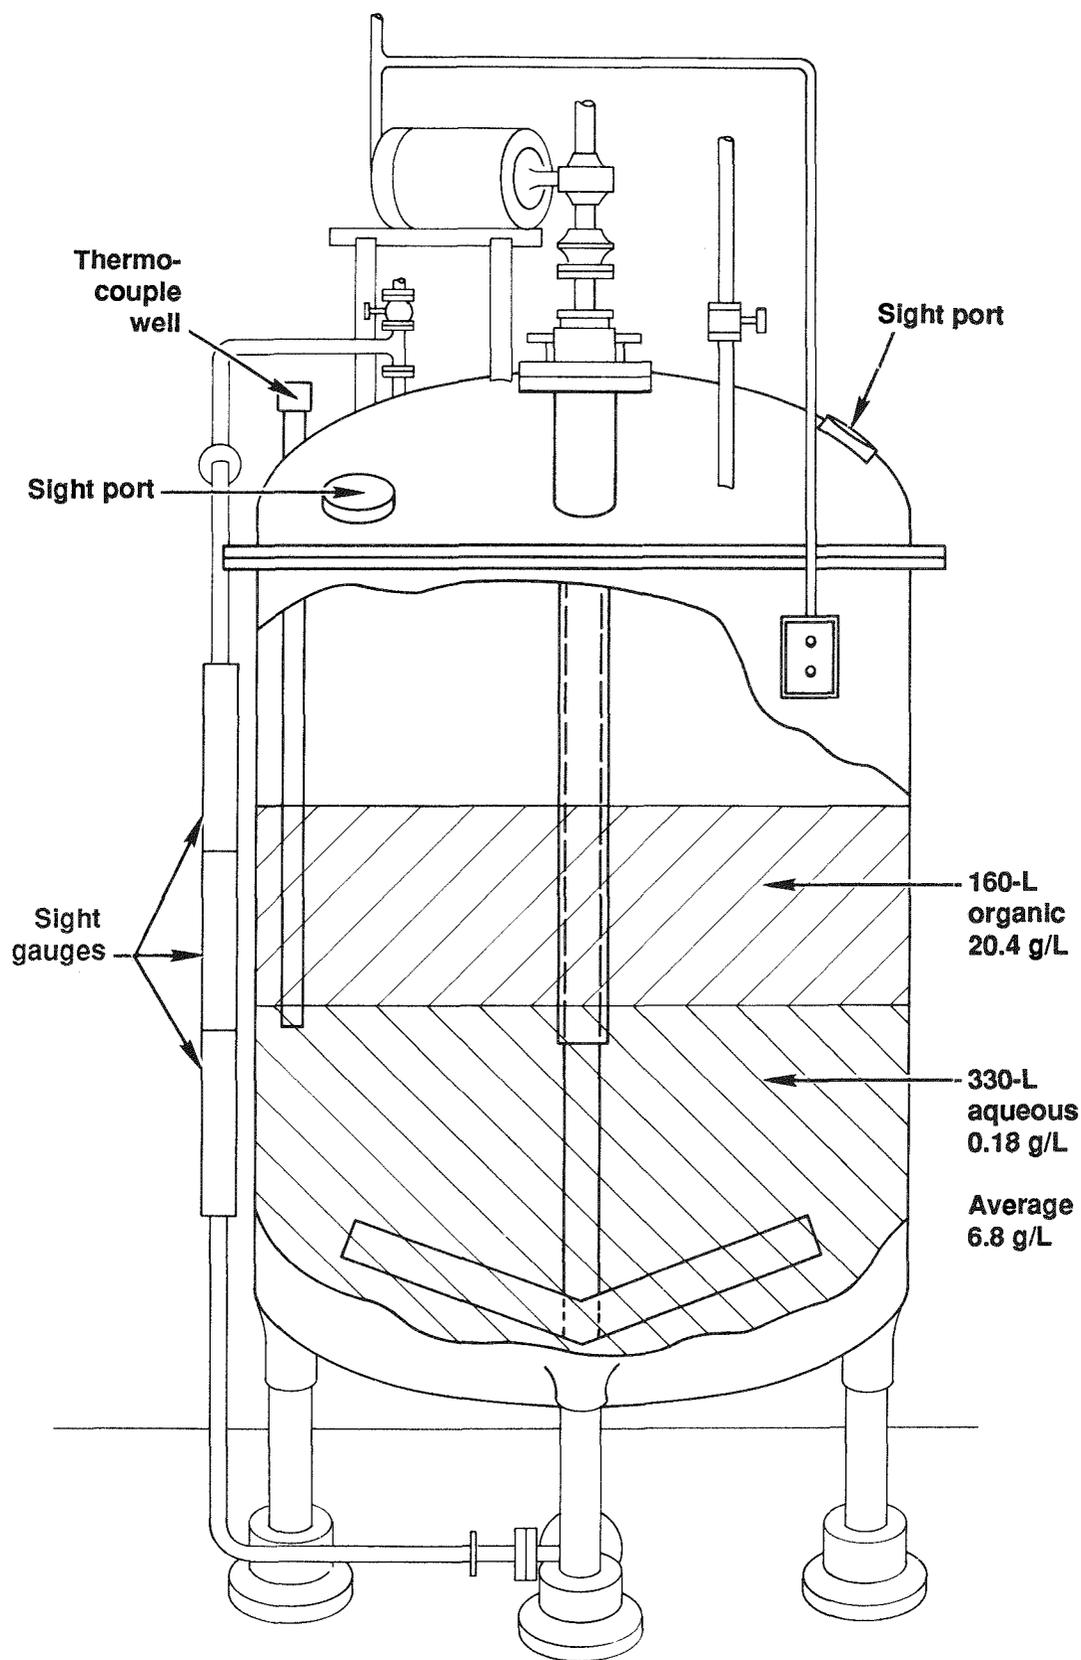
Fig. 3. Configuration of the 850 L plutonium solution tank prior to the accident.

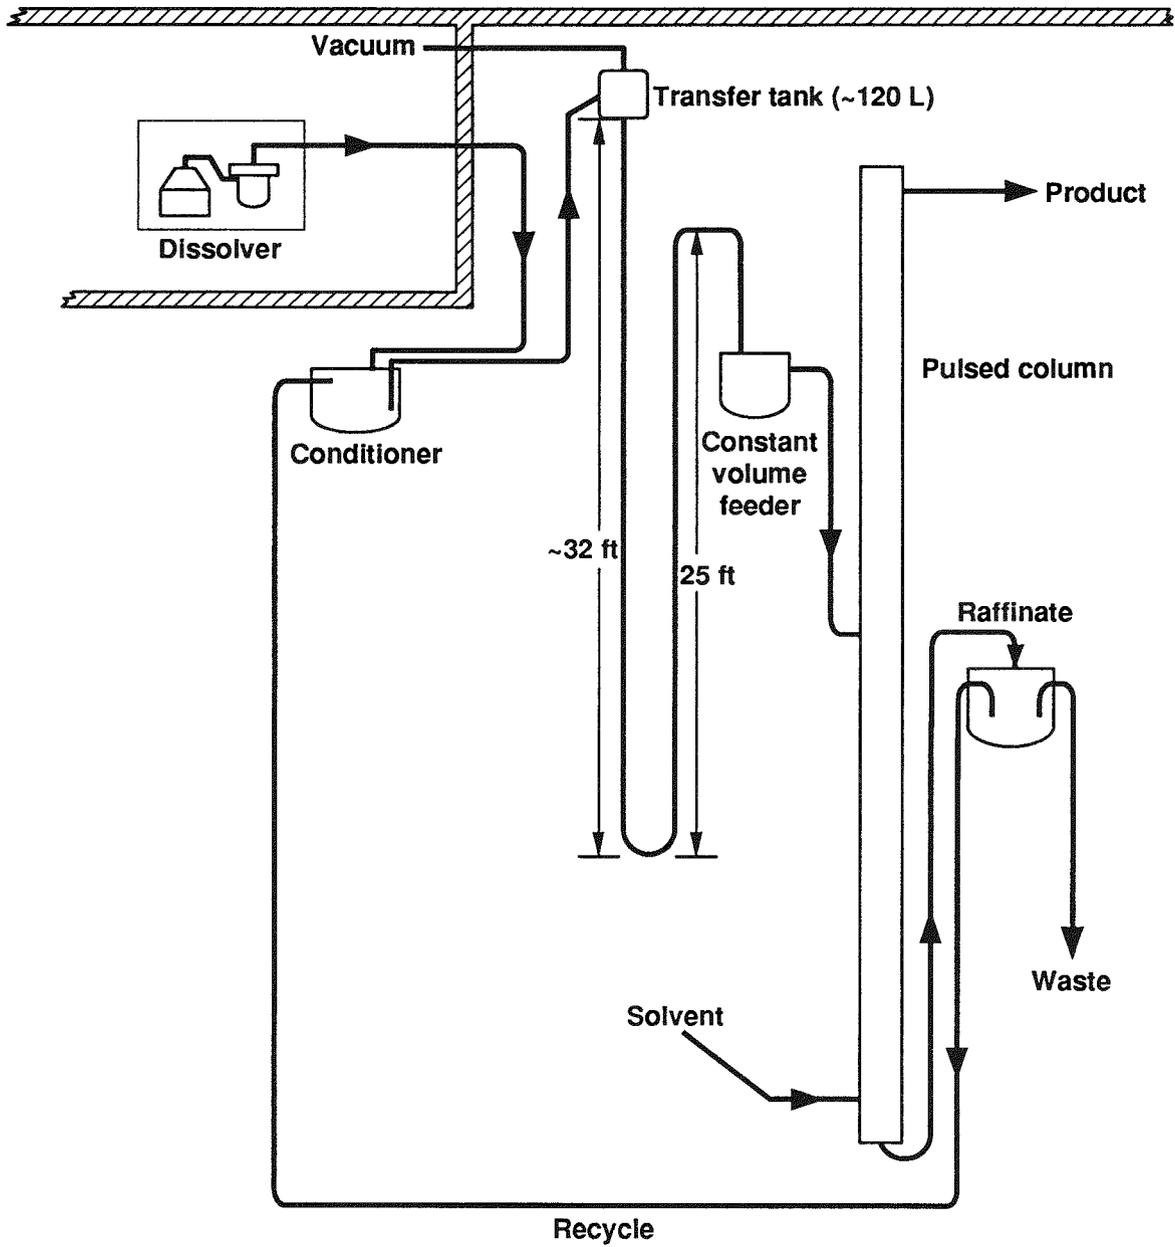
The solution was vacuum-lifted from the conditioner to a transfer tank (Fig. 4). When the transfer was completed, the vacuum was broken and the transfer tank was allowed to drain into a constant-volume feeder that supplied a favorable-geometry, pulsed, solvent-extraction column. The connection from the transfer tank to the constant-volume feeder was through a 25-ft-deep trap, or lute, that prevented any potential backflow and thus controlled contamination.

Fig. 4. The British Nuclear Fuels, Ltd., process line at Windscale.

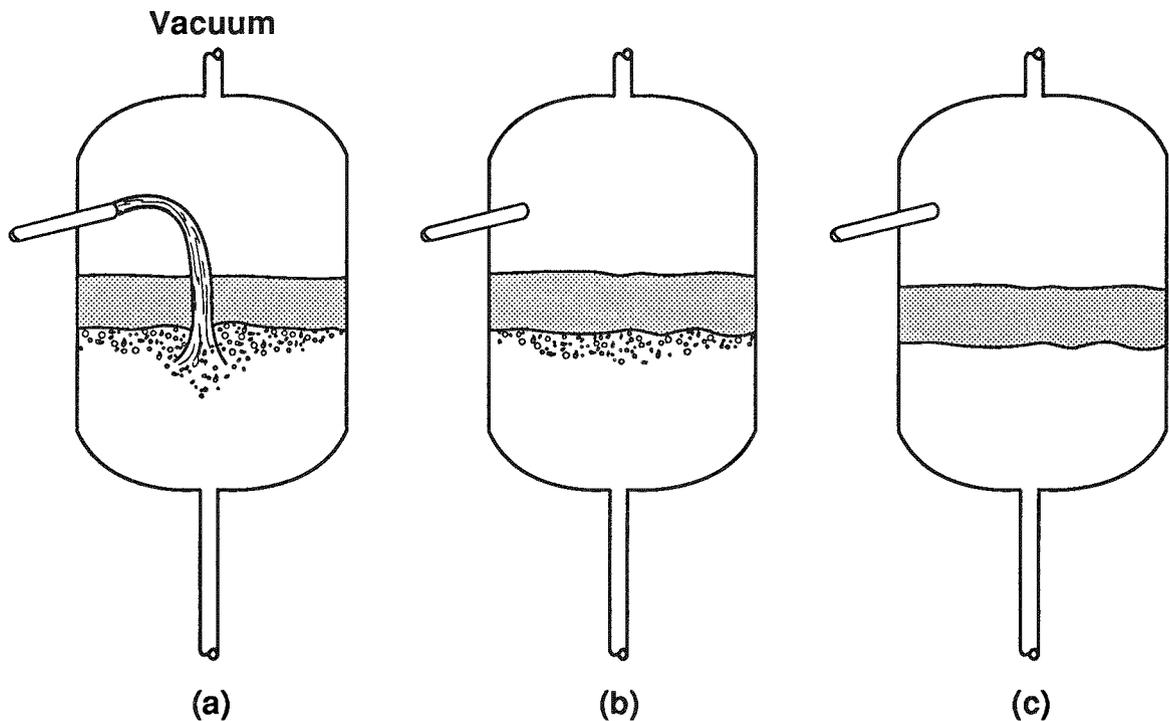
A transparent plastic mockup of the transfer tank was used to observe the configuration of the liquids during transfer. The situation existing during the transfer is shown in Fig. 5a. Rich organic (55 g/L) is floating on top of lean aqueous liquor (6 to 7 g/L). The aqueous stream pouring into the center of the tank provides a region of low reactivity. Between the organic and aqueous is a region of mixed phases, about 3 in. thick near the axis of the tank. This configuration is subcritical.

Just after completion of the transfer (Fig. 5b) the central plug of aqueous liquor has disappeared, the region of mixed phases is still present, and the configuration has a maximum value of the multiplication factor. Separation of the two phases occurs within a few seconds of completing the transfer (Fig. 5c). Monte Carlo calculations have indicated that the reactivity of Fig. 5b is about 5 \$ greater than that of Fig. 5a and about 10 to 15 \$ greater than Fig. 5c.

Fig. 5. Solution transfer in the Windscale process line.

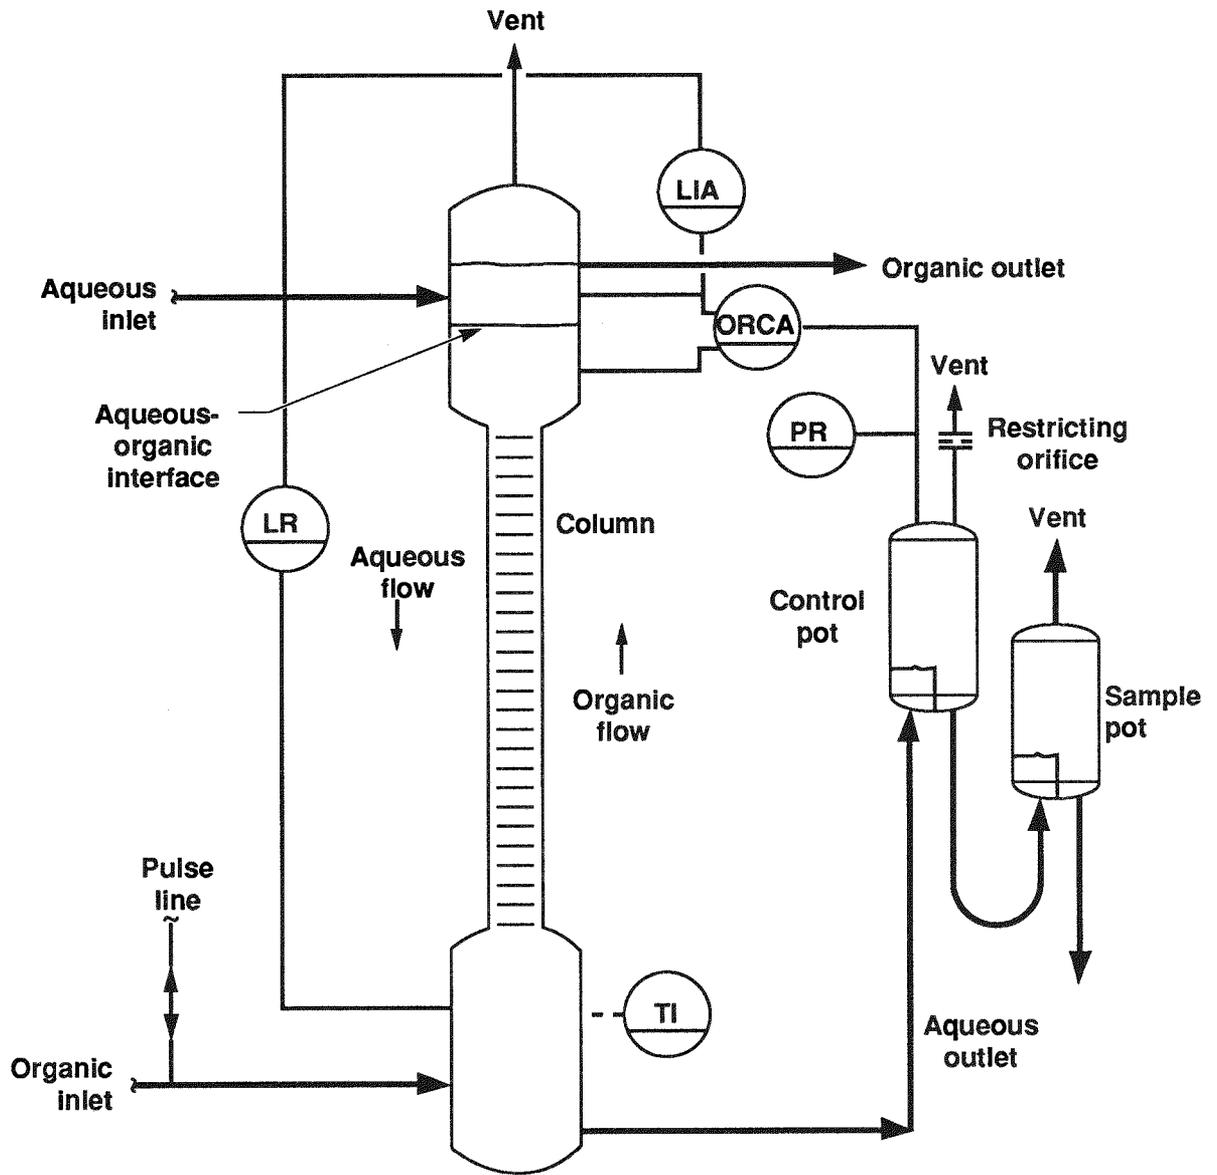
Fig. 6. H-100 Scrub Column.

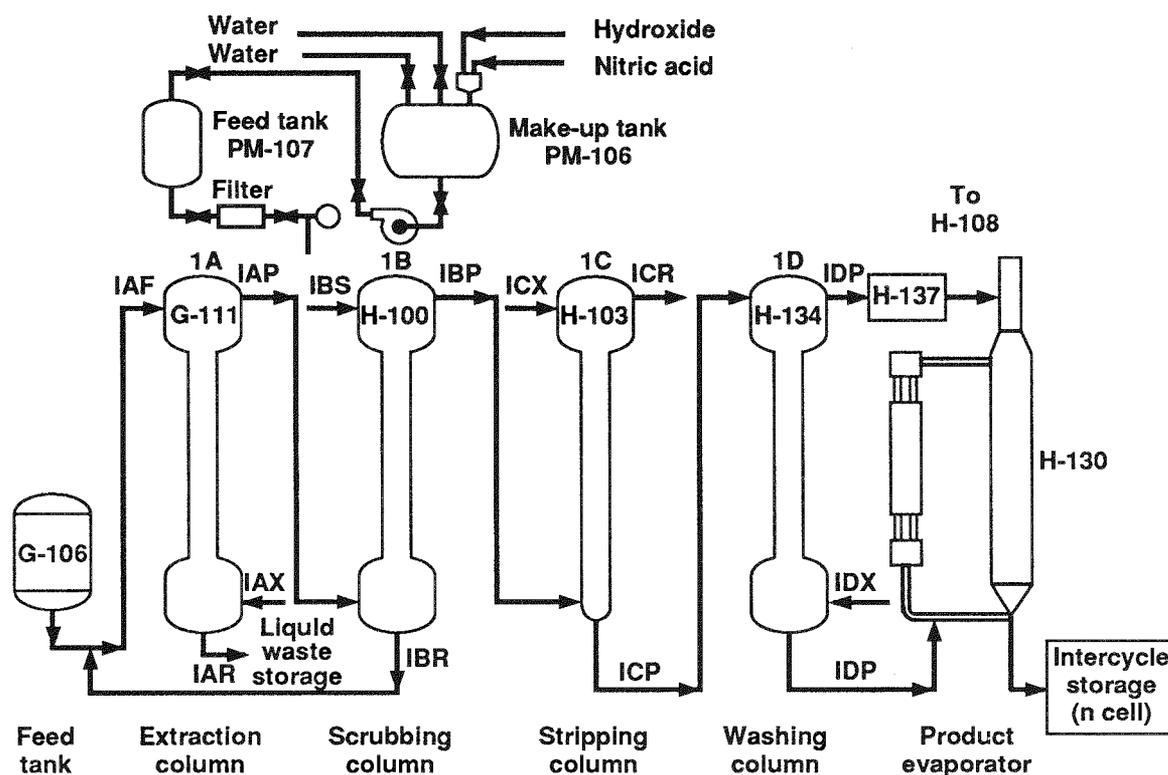
Fig. 7. First-cycle extraction line, Idaho Chemical Processing Plant.

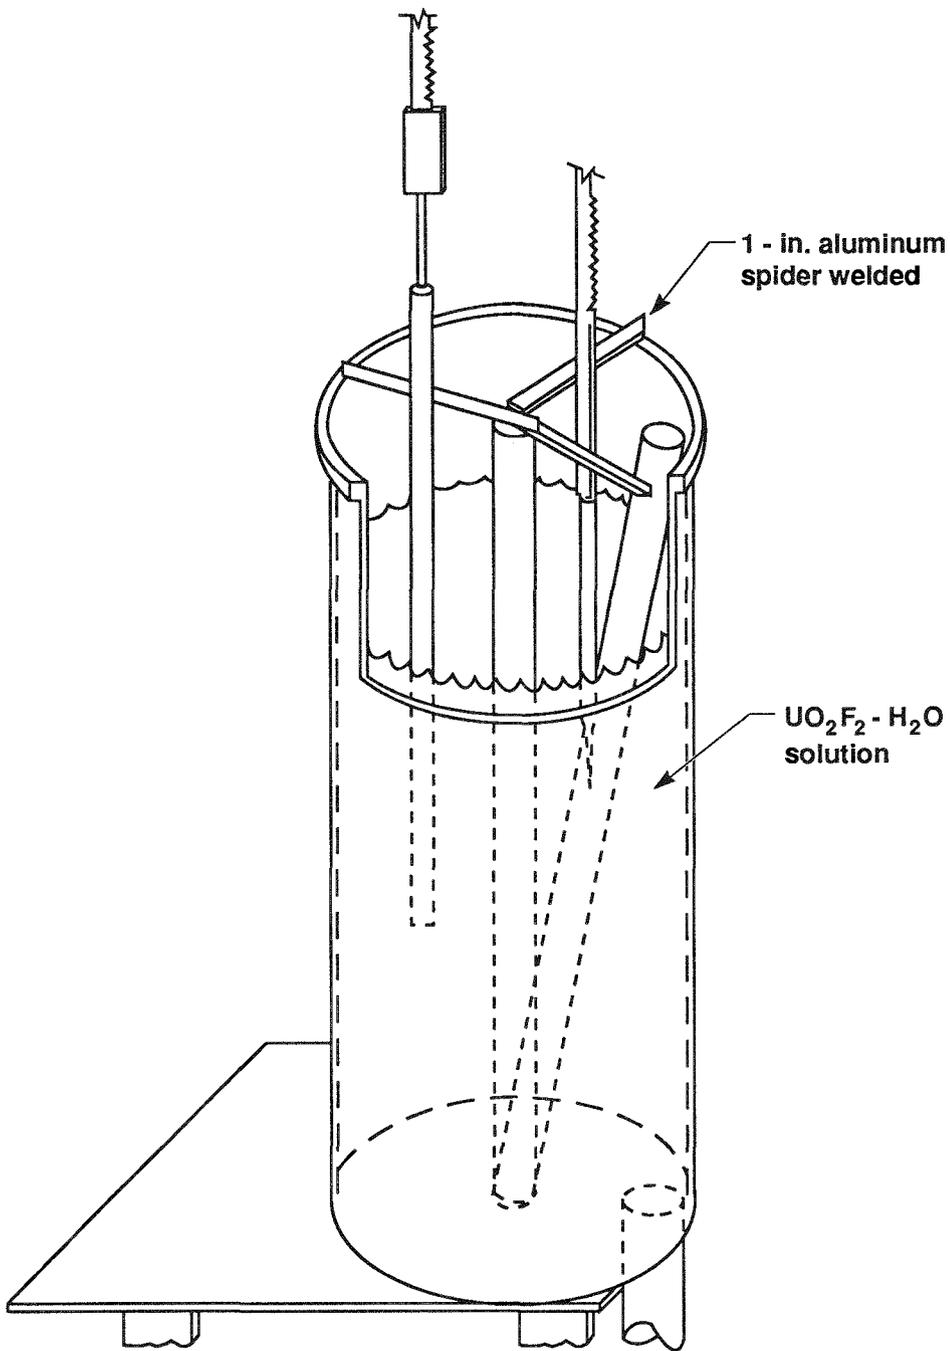
Fig. 8. The ORNL uranium solution assembly showing the normal and detached positions of the central poison rod.

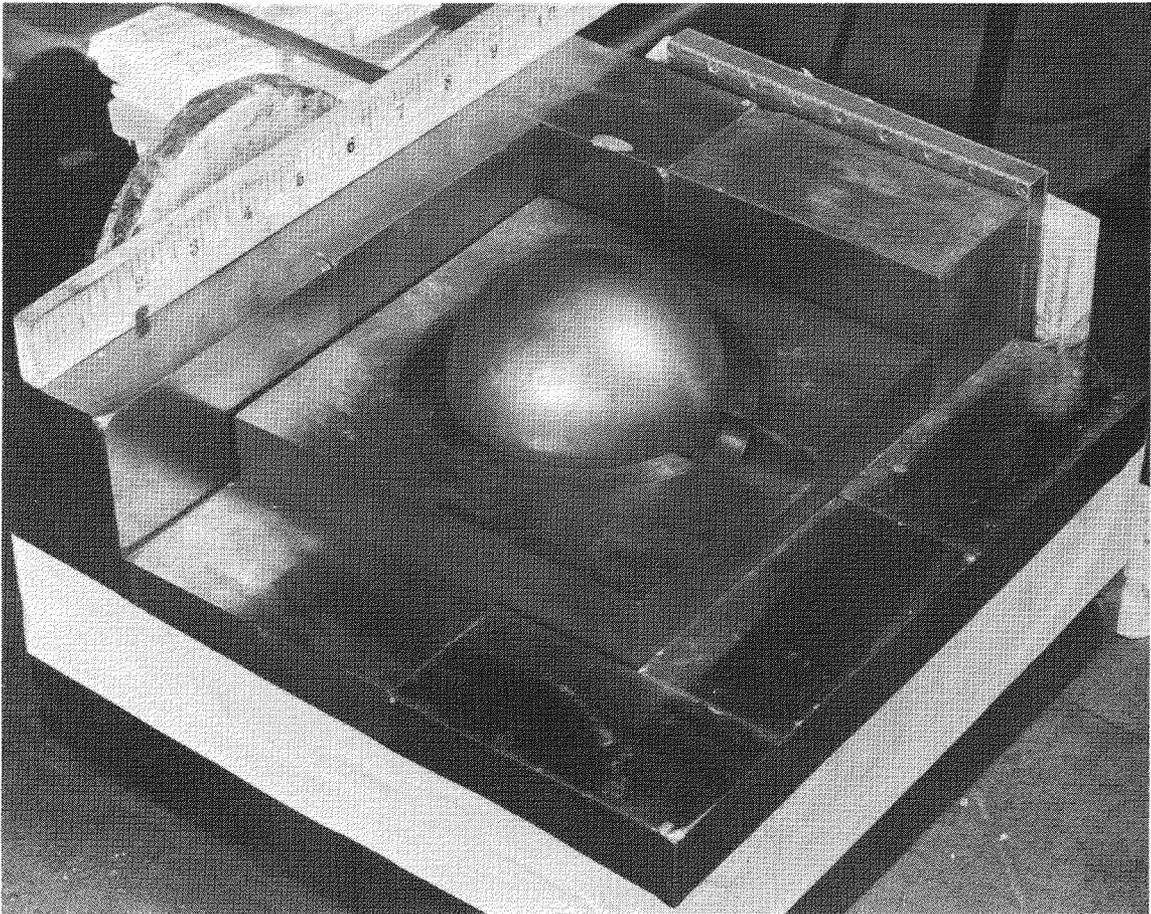
In the first accident, a critical assembly was being created by hand stacking 4.4 kg tungsten-carbide bricks around the plutonium core. Figure 9 shows a reenactment\* of the configuration with about half of the tungsten blocks in place.

Fig. 9. Plutonium sphere partially reflected by tungsten-carbide blocks.

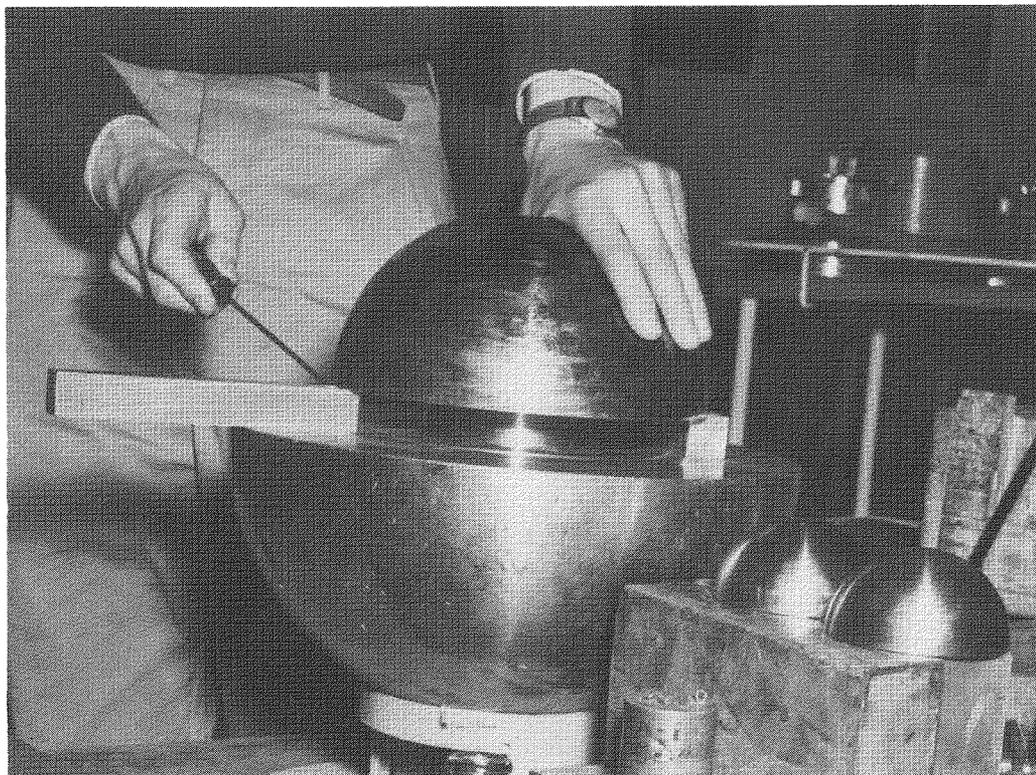
Fig. 10. Configuration of beryllium reflector shells prior to the accident May 21, 1946.

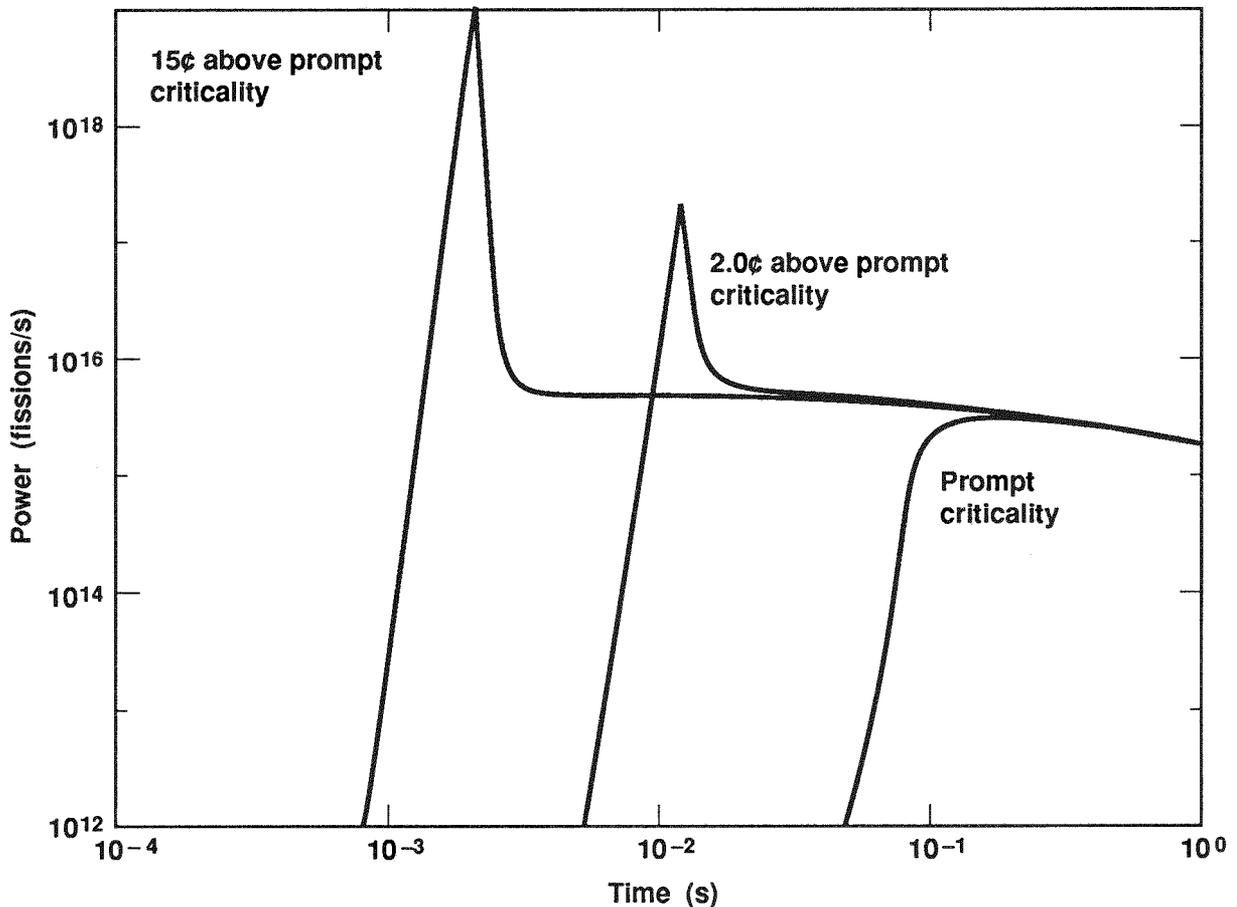
The results of calculations of the fission rate in this sphere, as a function of time for several values of excess reactivity, are shown in Fig. 11. Fig. 12 represents the total number of fissions to be expected as a function of time for the same excess reactivities.\* These data are applicable to both accidents because the difference in reflector material has only a small effect on the neutron kinetics. In the first excursion, if the excess reactivity did not exceed 0.15 \$, the assembly must have been together for several seconds, which is not unreasonable. In the second event, the experimenter was better prepared to disassemble the material, and it is thought that this was done in a fraction of a second, perhaps less than 1/2 s. The known parameters would then be satisfied by an excess reactivity of about 0.10 \$.

Fig. 11. Calculated fission rate for 6.2-kg plutonium sphere.

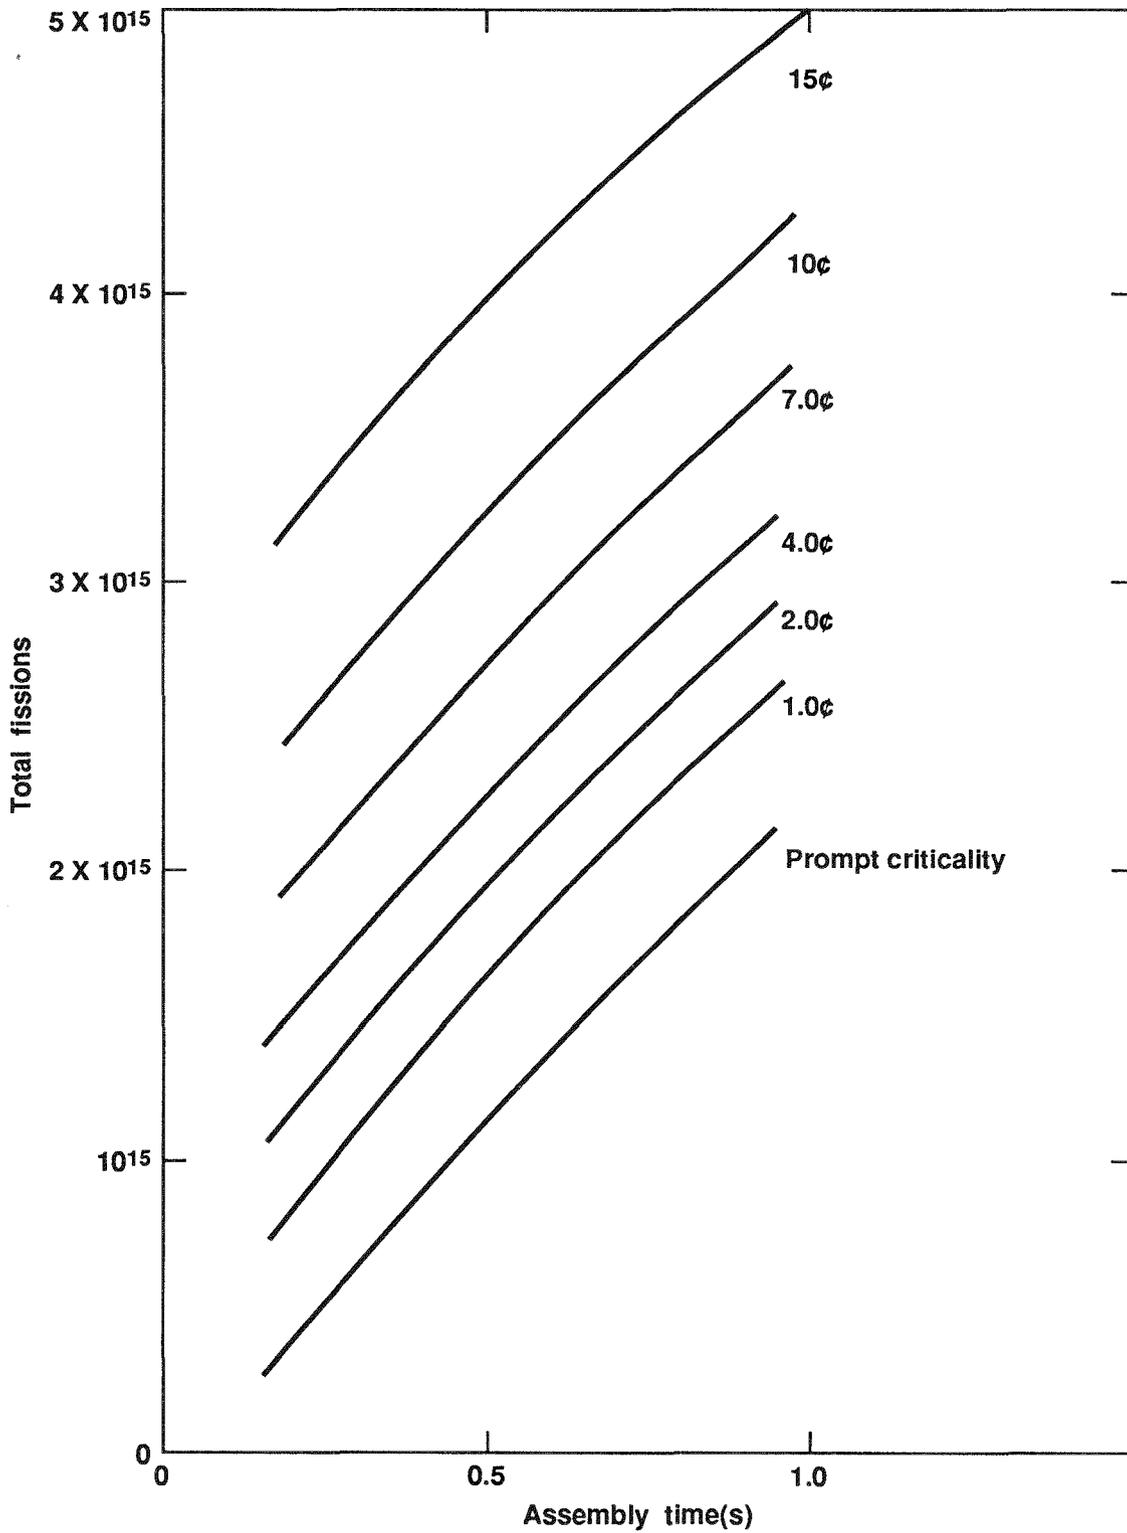
Fig. 12. Calculated total fissions vs time for the 6.2-kg plutonium sphere.

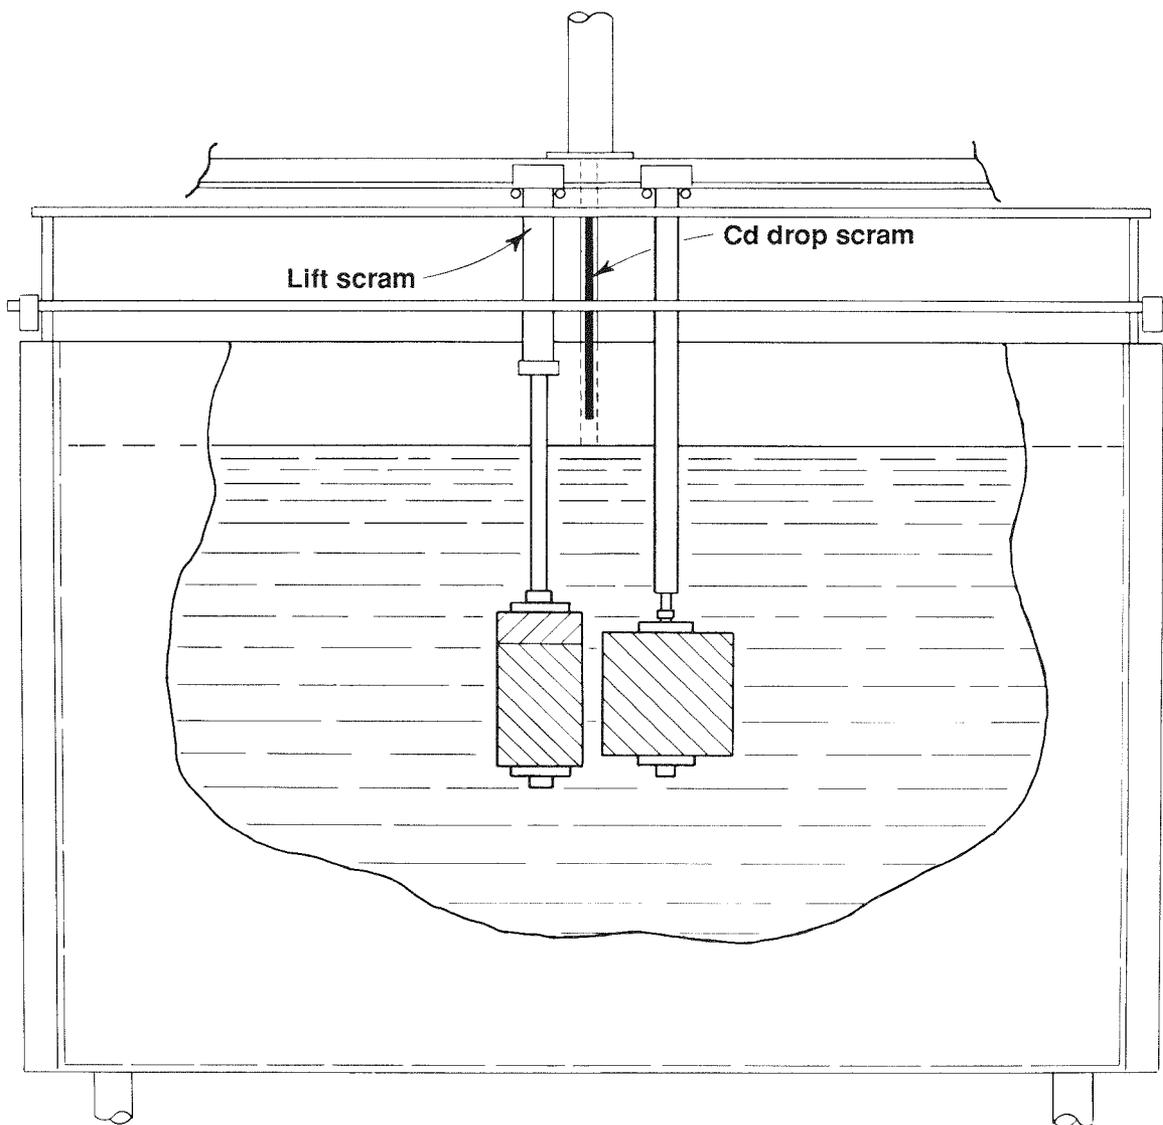
Fig. 13. The LASL aquarium assembly machine employed for measurements of critical separation distances.

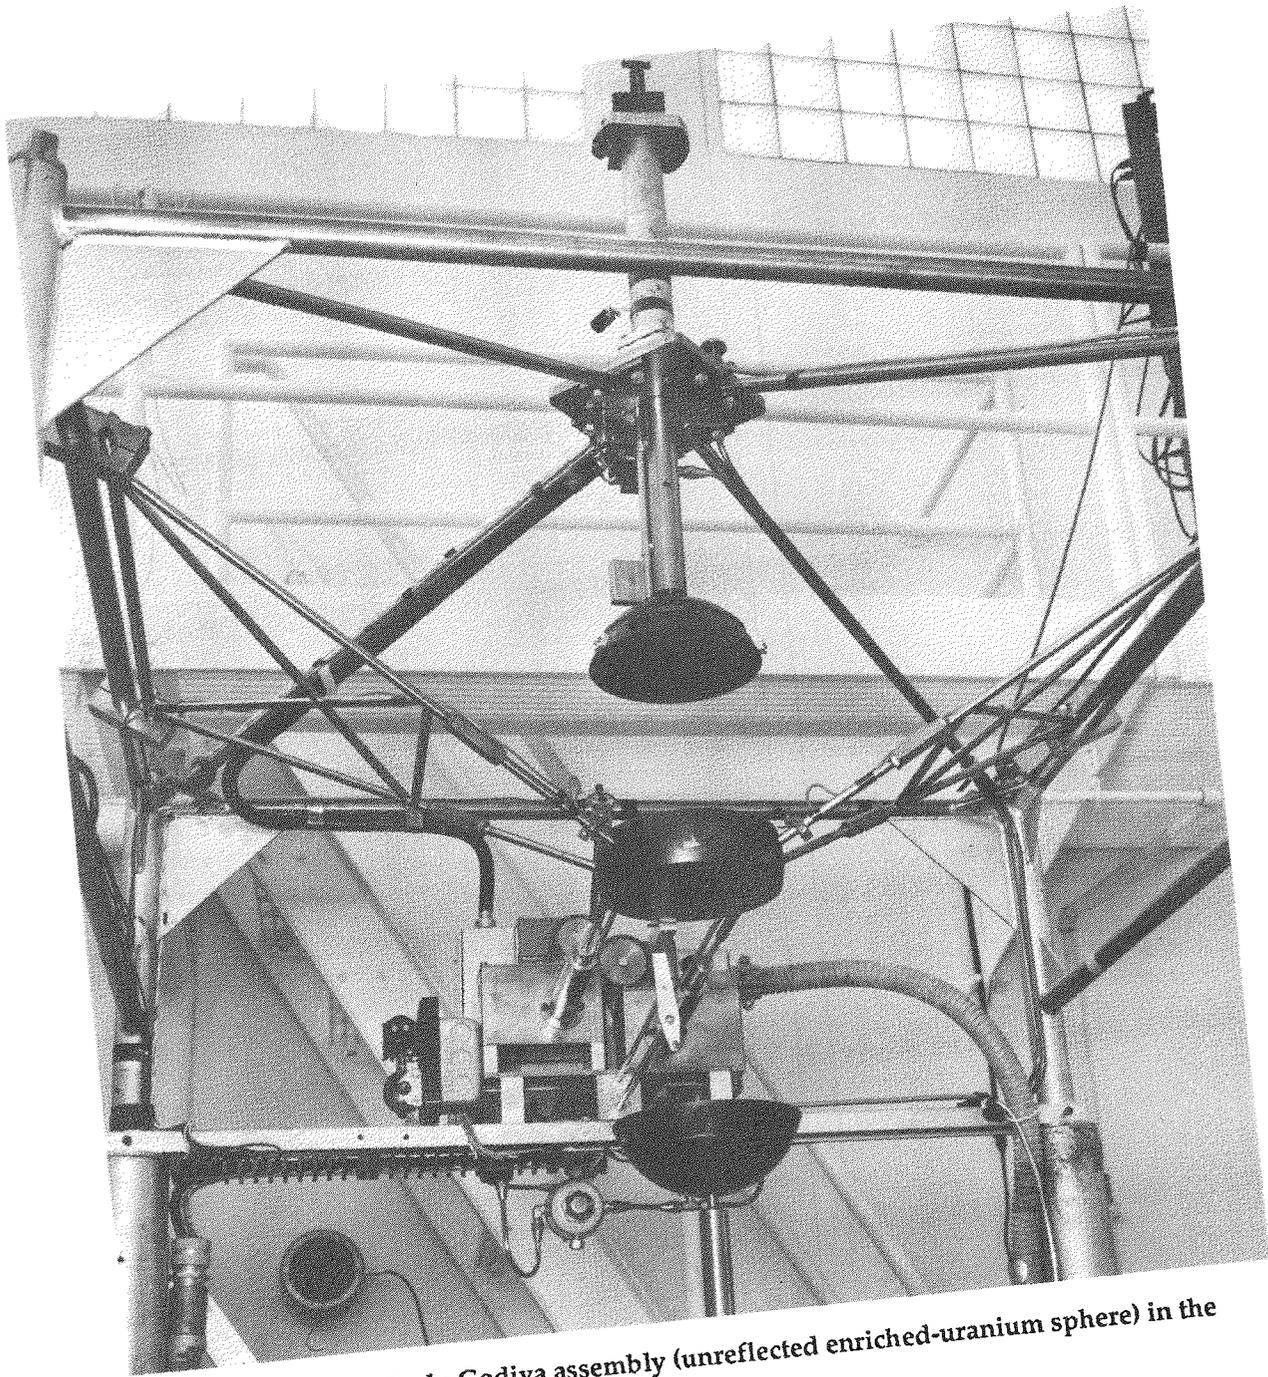
**Fig. 14. The LASL Lady Godiva assembly (unreflected enriched-uranium sphere) in the scrambled configuration.**

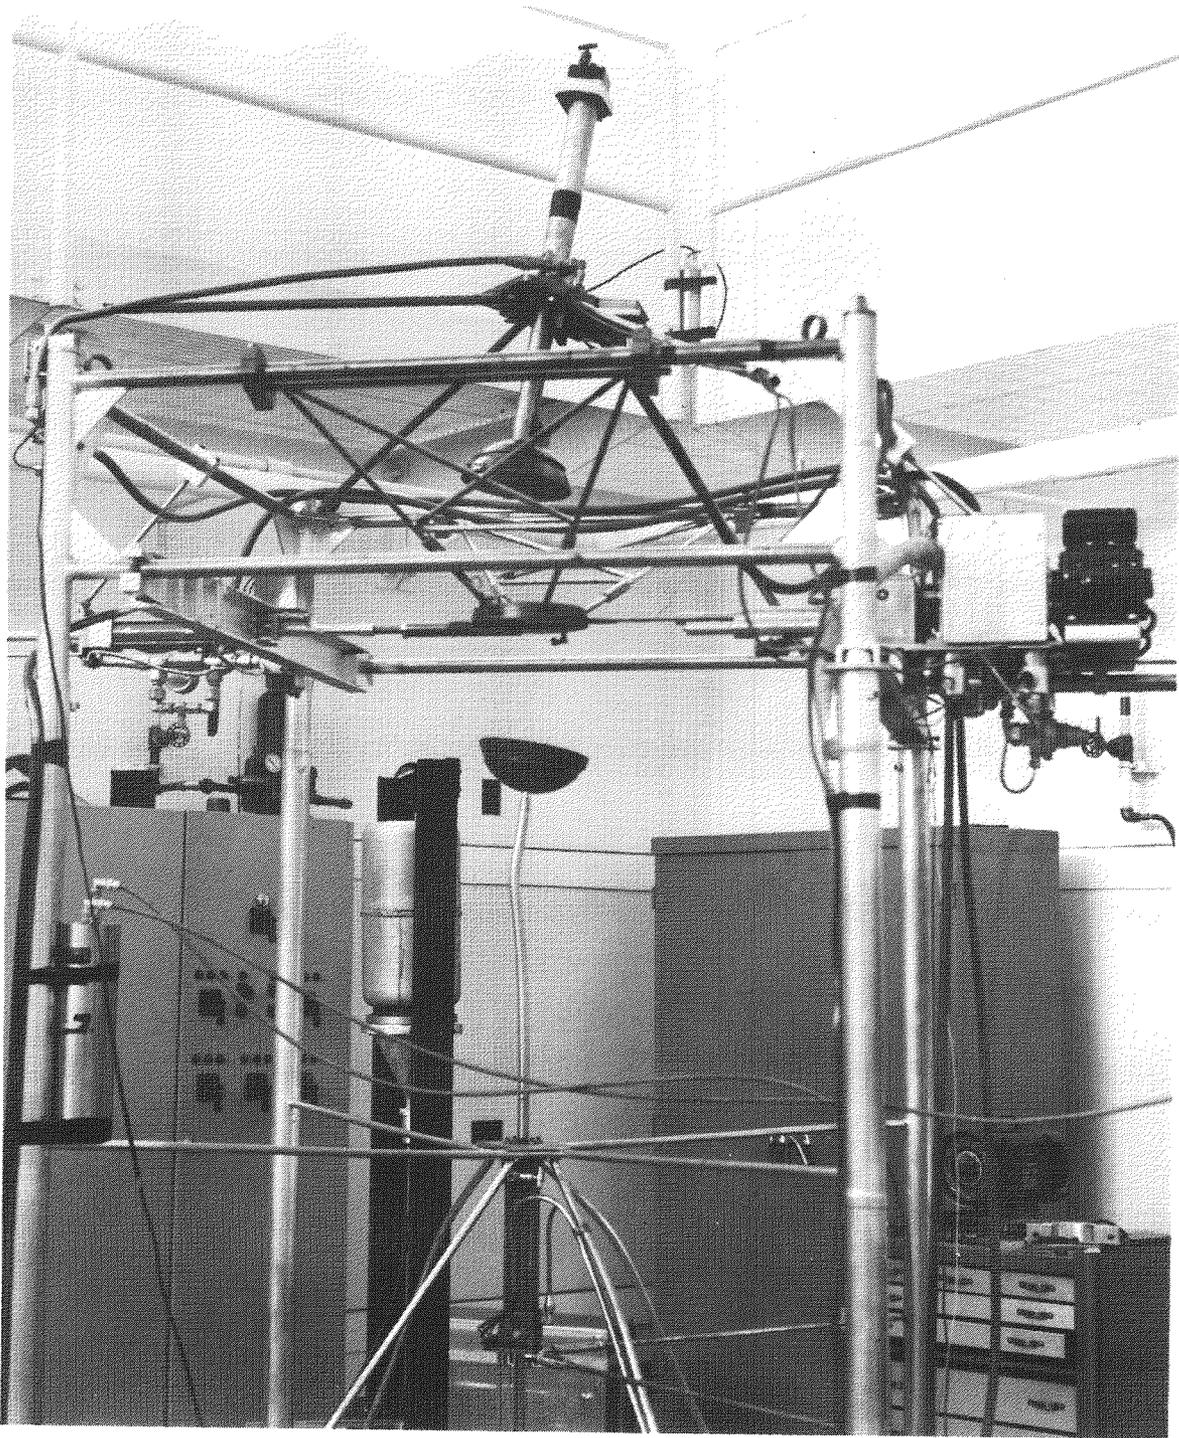
The excursion yield was  $5.6 \times 10^{16}$  fissions, about six times the yield of the average burst. There was no radiation hazard, spreading of contamination, personnel radiation, or significant damage to the major uranium parts. One piece was slightly warped and required remachining. Several light steel supporting members were bent or broken (Fig. 15).

Fig. 15. Lady Godiva after the excursion of February 3, 1954 .

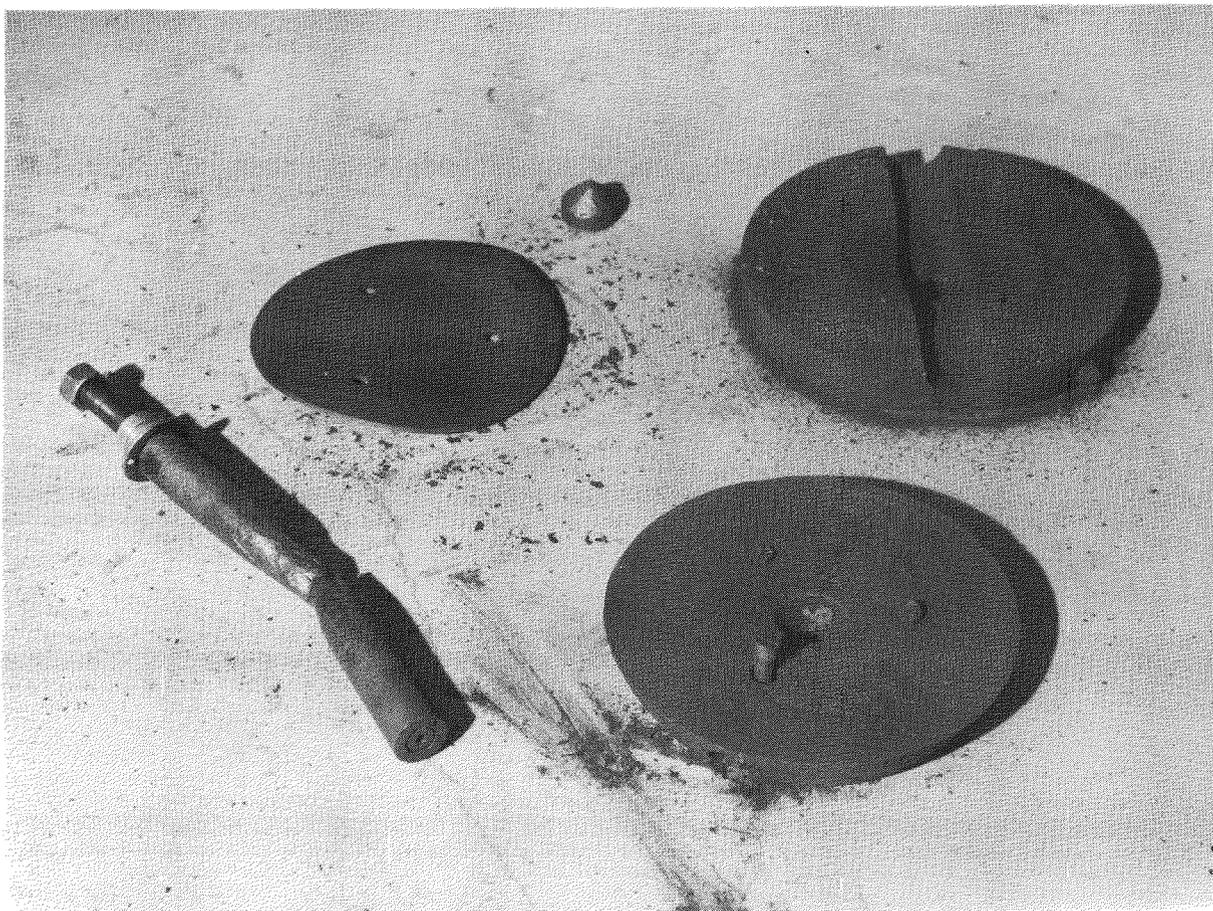
Fig. 16. Burst rod and several sections of Lady Godiva showing oxidation and warpage that accompanied the second accident.

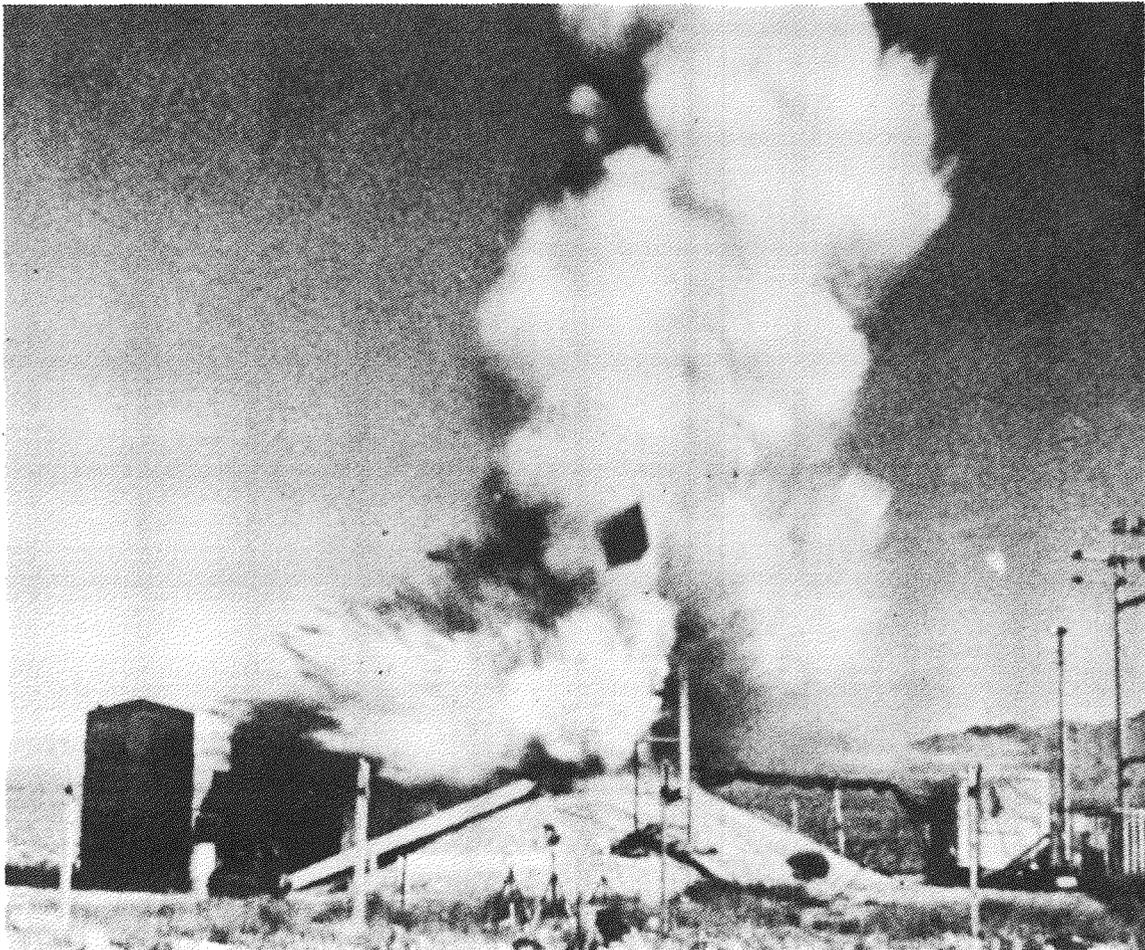
The excursion and associated steam explosion, following rapid ejection of the control rod, completely disassembled the reactor core and ruptured the reactor tank (Fig. 17). Very extensive melting of the fuel plates occurred; some elements remained in the tank while small pieces were found up to 200 ft away.

Fig. 17. The destructive excursion in BORAX, July 22, 1954.
