# A Review of Criticality Accidents

William R. Stratton

revised by  
David R. Smith

March 1989

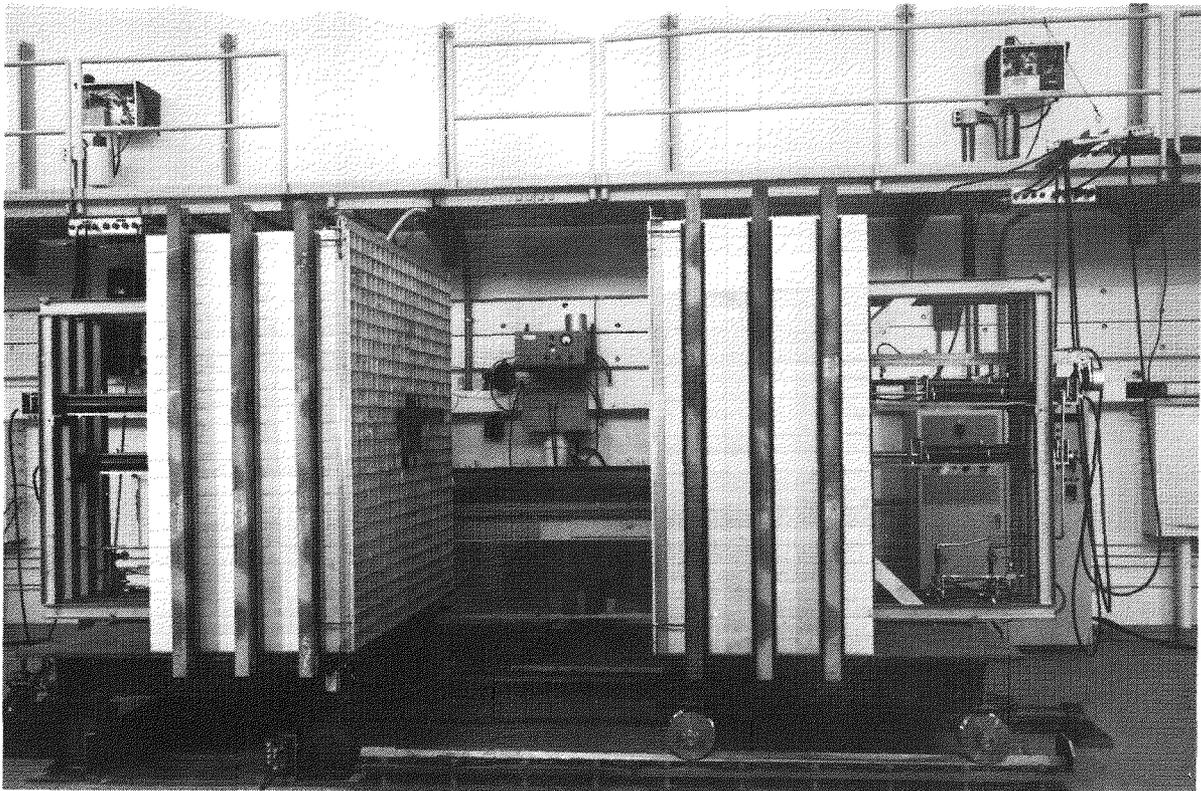
**Fig. 18.** The LASL Honeycomb assembly machine. The movable section (right) is in the withdrawn position and the aluminum matrix is only partially loaded.

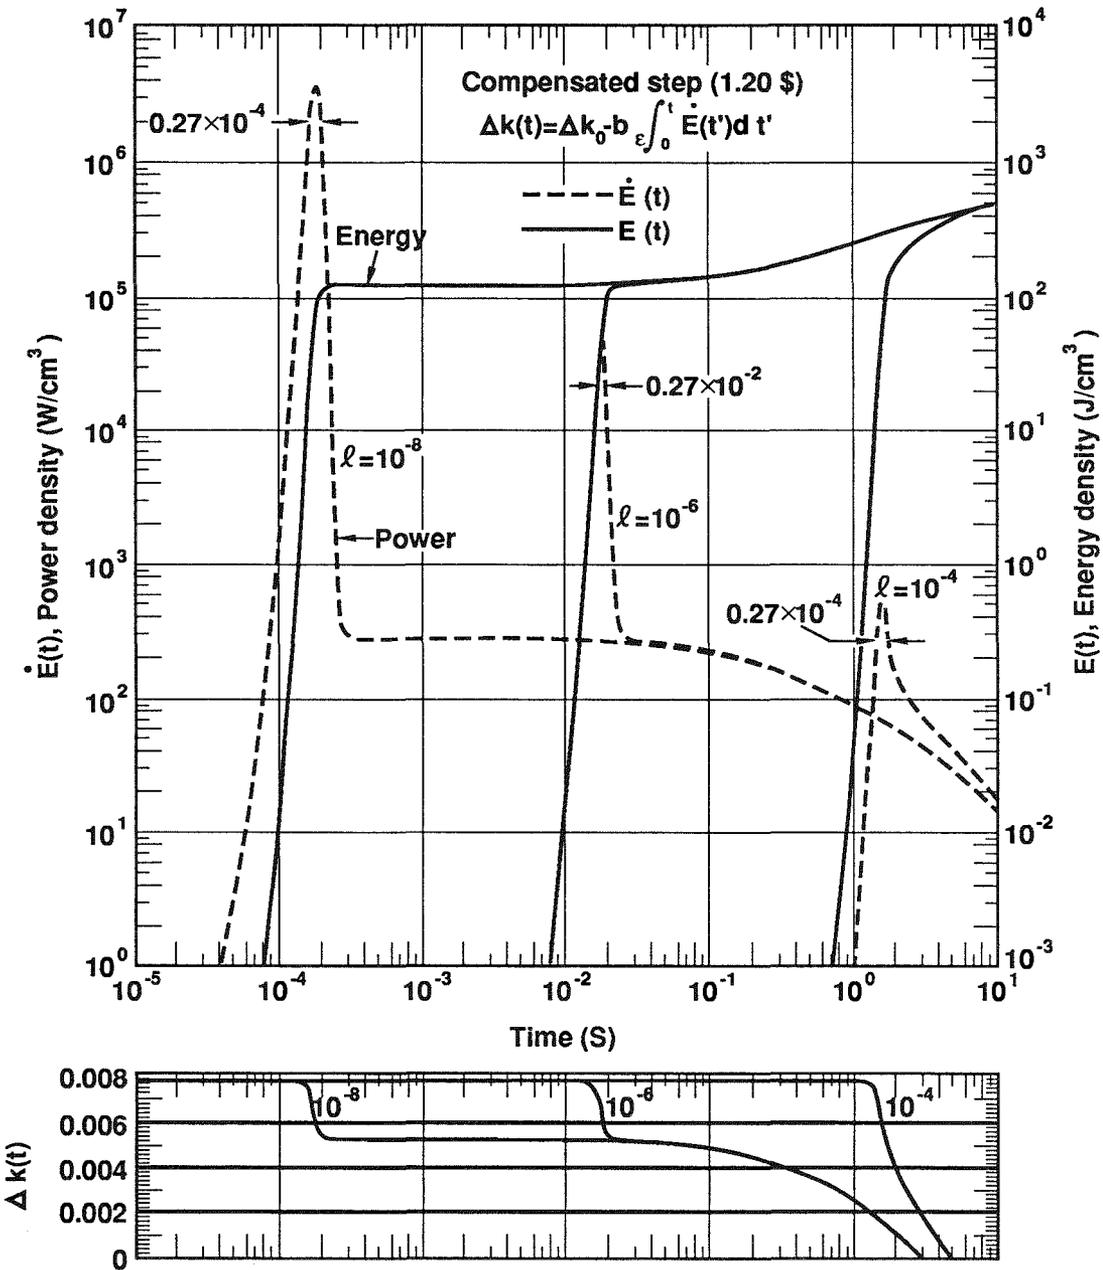
Figure 19 illustrates a series of computations for hypothetical systems in which the step increase of  $\Delta k$  is 1.20 \$ relative to delayed criticality, the value of  $b$  is constant, and the neutron lifetime  $l$  is varied from  $10^{-8}$  to  $10^{-4}$  s. The power and reactivity traces for the short neutron lifetime cases are characteristic of prompt excursions in fast reactors. The very sharp rise and fall in power is called the spike, and the relatively constant power following the spike is the plateau. During the spike, the reactivity changes by  $2 \Delta k_0$ —that is, it reflects about prompt criticality. The characteristics of such spikes are established almost entirely by the prompt neutrons. The traces for  $l = 10^{-4}$  (simulating a solution system or a moderated reactor) do not show the reflection about prompt criticality, and there is no well-defined plateau following the spike. The time scale is of the order of the decay times of the shorter delayed neutron precursor; the effects of these neutrons cannot be ignored.

Fig. 19. Energy model computation of power vs time and energy release vs time for an initial reactivity of 1.2 \$ above delayed critical for neutron lifetime values of  $l = 10^{-8}$ ,  $10^{-6}$ , and  $10^{-4}$  s. Below are the corresponding curves of reactivity vs time.

Some of the results shown in Figs. 19 and 20 can be obtained analytically. For sufficiently large step increases in reactivity above prompt criticality, the delayed neutrons may be ignored and the kinetic equations integrated to give the total excursion yield.\*

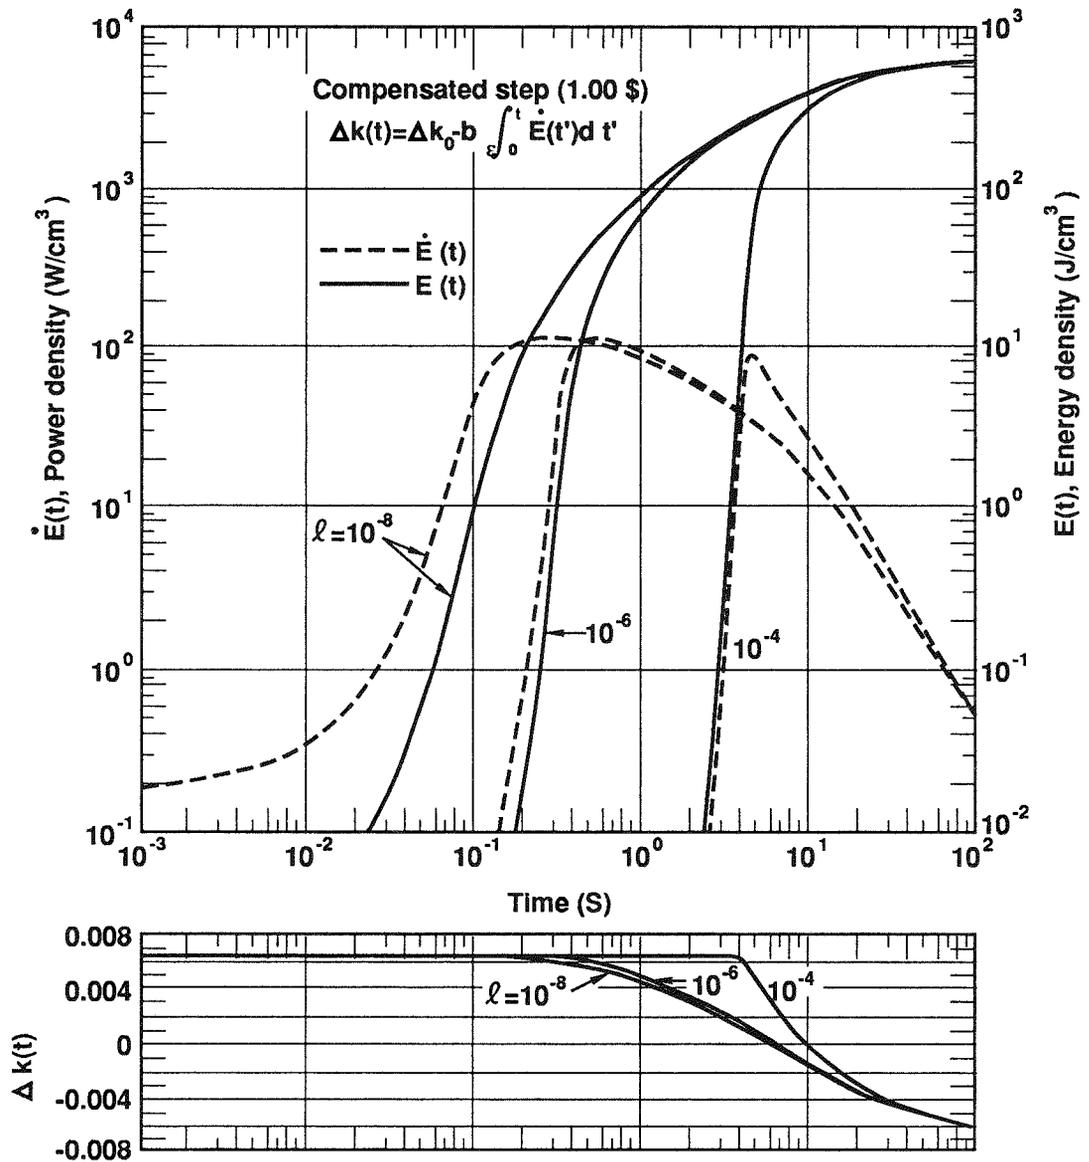
Figure 20 illustrates comparable data for a step increase in reactivity of 1.0 \$. The time history of the reactivity and power in this case is quite different and, indeed, is typical of excursions in the delayed critical region. The time scale is much extended, allowing the possibility of mechanical devices shutting off the transient; power peaks are broader; and the reactivity now attempts to reflect about delayed criticality. It should be noted that the implicit assumption of no heat loss from the system cannot be realized in practice. Any such loss of energy would result in power values greater than those plotted.

Fig. 20. Energy model computation of power vs time for an initial reactivity of 1.0 \$ above delayed critical for neutron lifetime values of  $\ell = 10^{-8}$ ,  $10^{-6}$ , and  $10^{-4}$  s. Below are the corresponding curves of reactivity vs time.

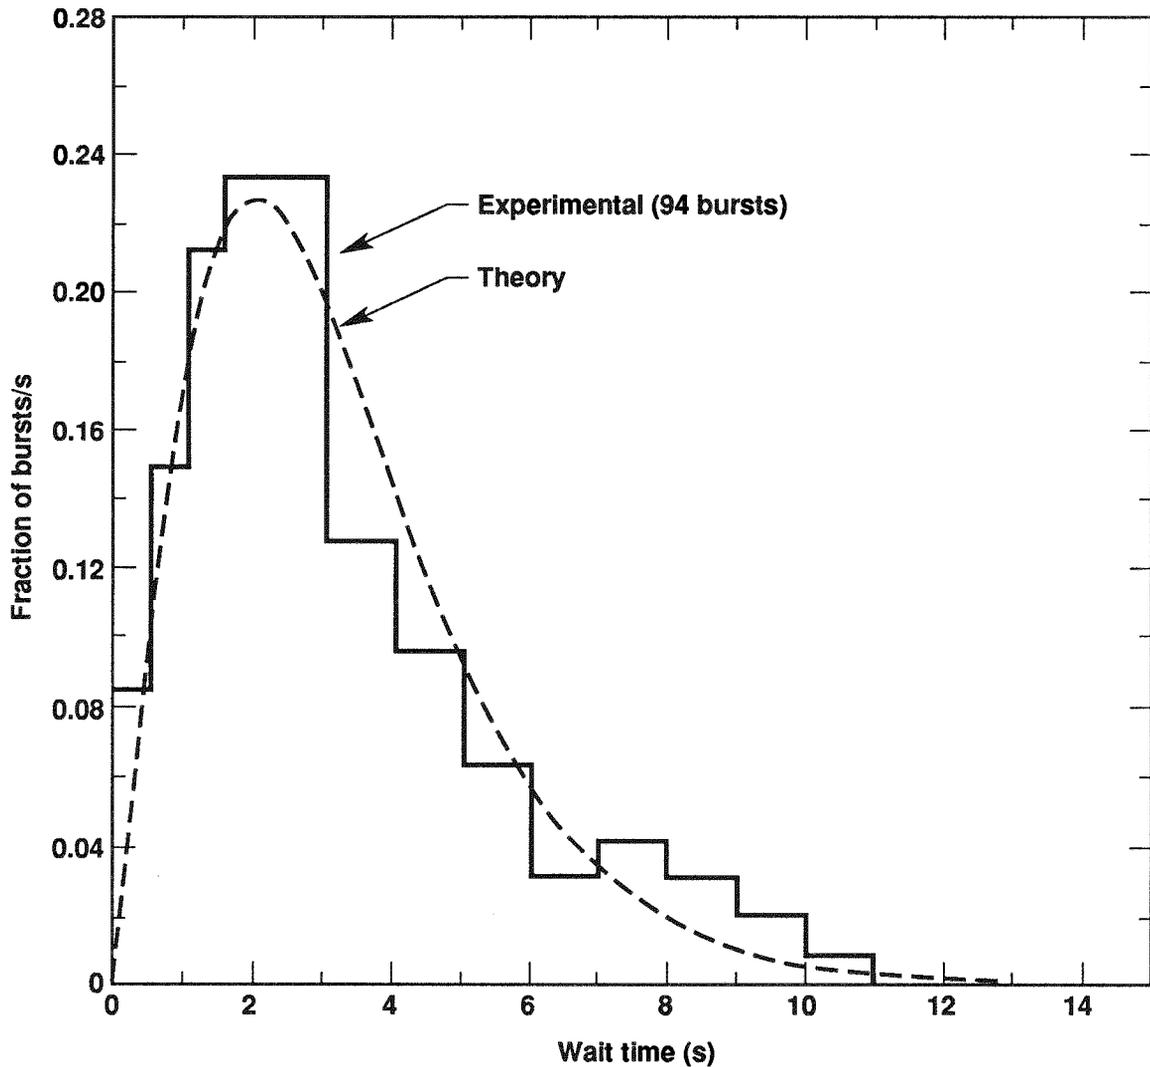
Fig. 21. Distribution in burst wait times after quick (about 50 ms) insertion of 1.05 \$ in Godiva II. Plotted is the fraction of bursts in each second vs wait time in seconds.
